King County
International Airport
Boeing Field

RE: Notice of Violation (NOV) No. 6180

PCB Source Control Investigation of the City of Tukwila Stormwater System

Jorgensen Pipe Discharge Area
City of Tukwila, WA

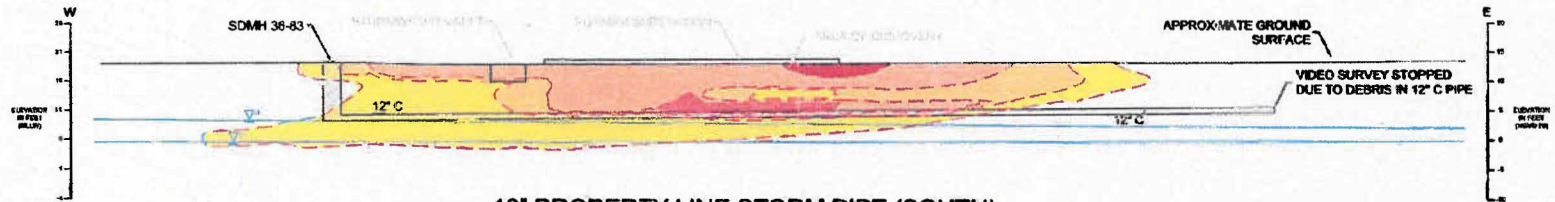
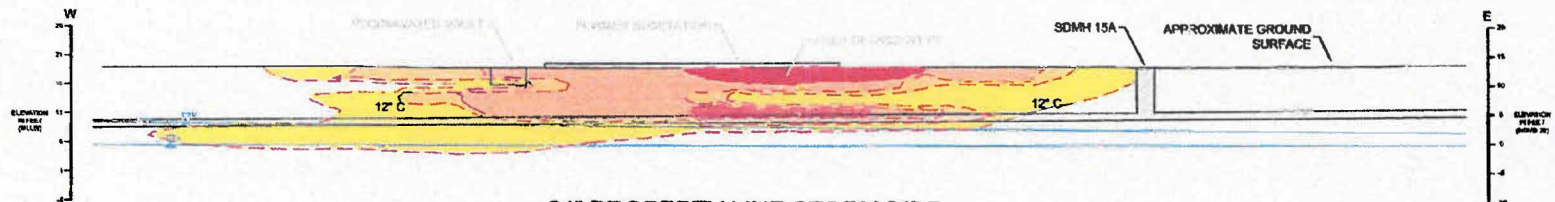
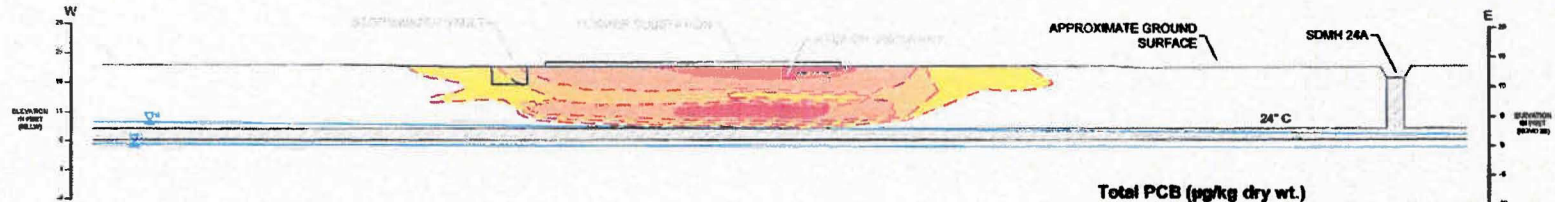
FIGURE 3.8
SUBSURFACE PCB DISTRIBUTION
ALONG STORM PIPE ALIGNMENTS

12" BOEING STORM PIPE (NORTH)

12" PROPERTY LINE STORM PIPE (SOUTH)

24" PROPERTY LINE STORM PIPE

Total PCB (µg/kg dry wt.)

⁴ See Floyd Snider, Phase II Transformer PCB Investigation Report Prepared for the Boeing Company, Seattle, Washington, August 3, 2005, Figure 3.8 (enclosed).

1. **Figure 24 – Jorgensen Forge Facility, Jorgensen Forge Facility – Boeing Plant 2 Facility, Property Line Stormwater Lines**
2. **Memorandum regarding Drainage Law Issue from Joseph B. Rochelle, Senior Deputy Prosecuting Attorney**
3. **Figure 3.8 – Subsurface PCB Distribution along Storm Pipe Alignments**
4. **PCB Source Control Investigation of the City of Tukwila Stormwater System**

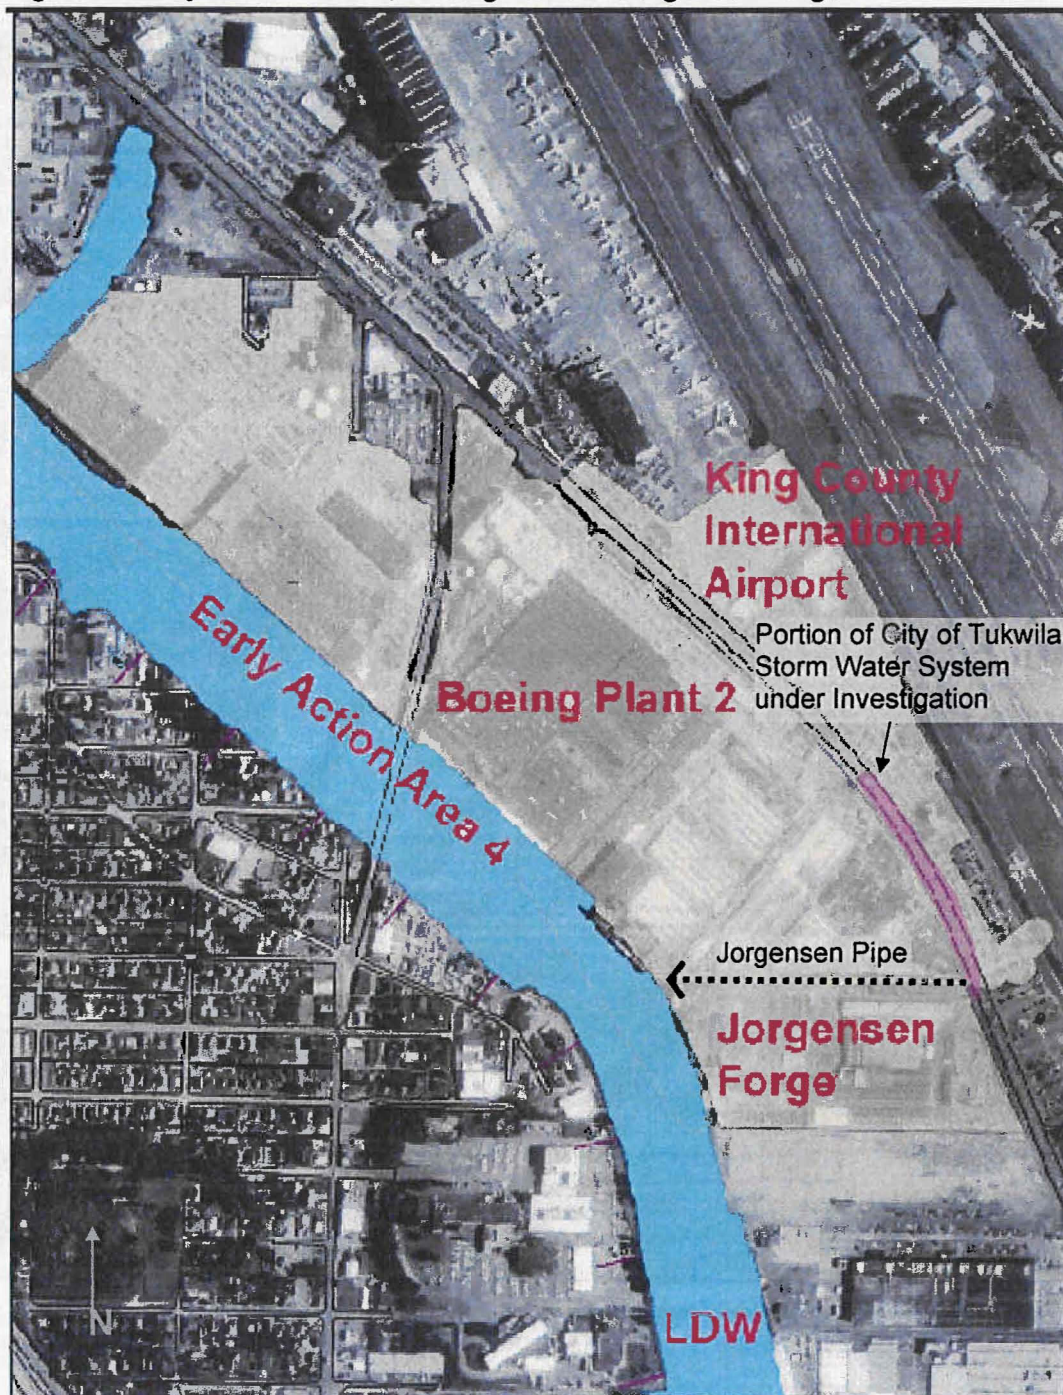
Figure 2: Early Action Area 4, Boeing Plant 2 / Jorgensen Forge

Figure adapted from: WA Department of Ecology, Lower Duwamish Waterway Source Control Investigation, EAA-4
http://www.ecy.wa.gov/programs/tcp/sites/lower_duwamish/sites/early_action_area4/early_action_area_4.htm

Early Action Area 4, the Boeing Plant 2/Jorgensen Forge site, is one of the areas within the LDW that was identified as having particularly high levels of PCBs. Recorded PCB concentrations in surface sediments along this stretch of the River measured as high as 110 mg/kg dry weight(dw). PCB levels above the Washington State Sediment Cleanup Levels were found in sediments at 0-2, 2-4 and 6-8 ft depths near the outfall of the Jorgensen pipe. Studies are still on-going to identify the possible sources of this contamination. A transformer on the Boeing Plant 2 site just north of the Jorgensen Pipe was identified as one likely source of contamination. Grout in the pavement on portions of the Boeing Plant 2 site may have also contributed to the elevated levels in this area. Fill material used at the Jorgensen Forge site is also suspected of PCB contamination. Elevated PCB levels have been found not only in river sediment samples but also in soil and groundwater samples taken in the vicinity of the pipe. However, the highest concentration of PCBs have been found inside the Jorgensen Pipe with levels as high as 10,000 mg/kg dw. Table 1 shows PCB levels that have been recorded over the years in the Jorgensen pipe and in the King County Airport stormwater system that drains to the Jorgensen Pipe.

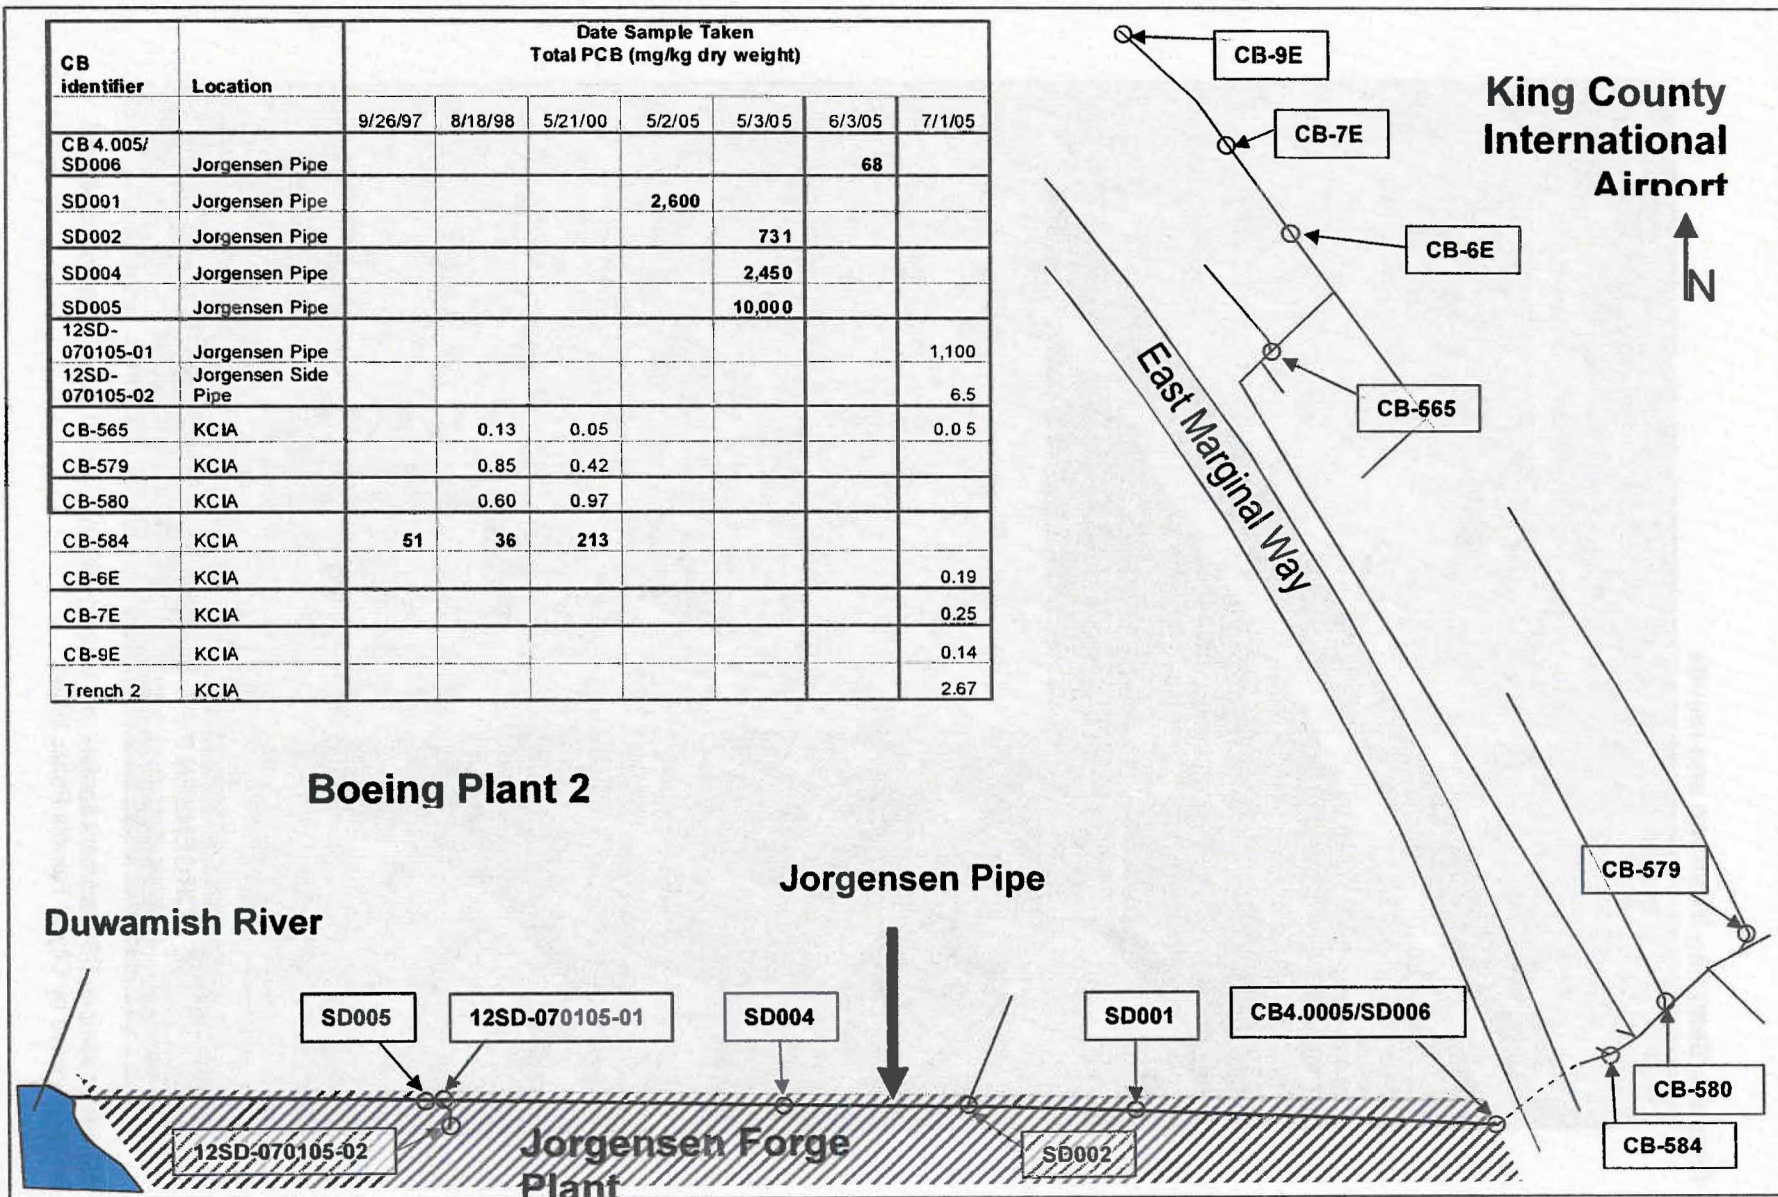
Figure 3: Previous PCB Sampling Locations and Results

CB identifier	Location	Date Sample Taken Total PCB (mg/kg dry weight)						
		9/26/97	8/18/98	5/21/00	5/2/05	5/3/05	6/3/05	7/1/05
CB 4.005/ SD006	Jorgensen Pipe						68	
SD001	Jorgensen Pipe				2,600			
SD002	Jorgensen Pipe					731		
SD004	Jorgensen Pipe					2,450		
SD005	Jorgensen Pipe					10,000		
12SD- 070105-01	Jorgensen Pipe							1,100
12SD- 070105-02	Jorgensen Side Pipe							6.5
CB-565	KCIA		0.13	0.05				0.05
CB-579	KCIA		0.85	0.42				
CB-580	KCIA		0.60	0.97				
CB-584	KCIA	51	36	213				
CB-6E	KCIA							0.19
CB-7E	KCIA							0.25
CB-9E	KCIA							0.14
Trench 2	KCIA							2.67

See Figure 3 for locations of catch basins

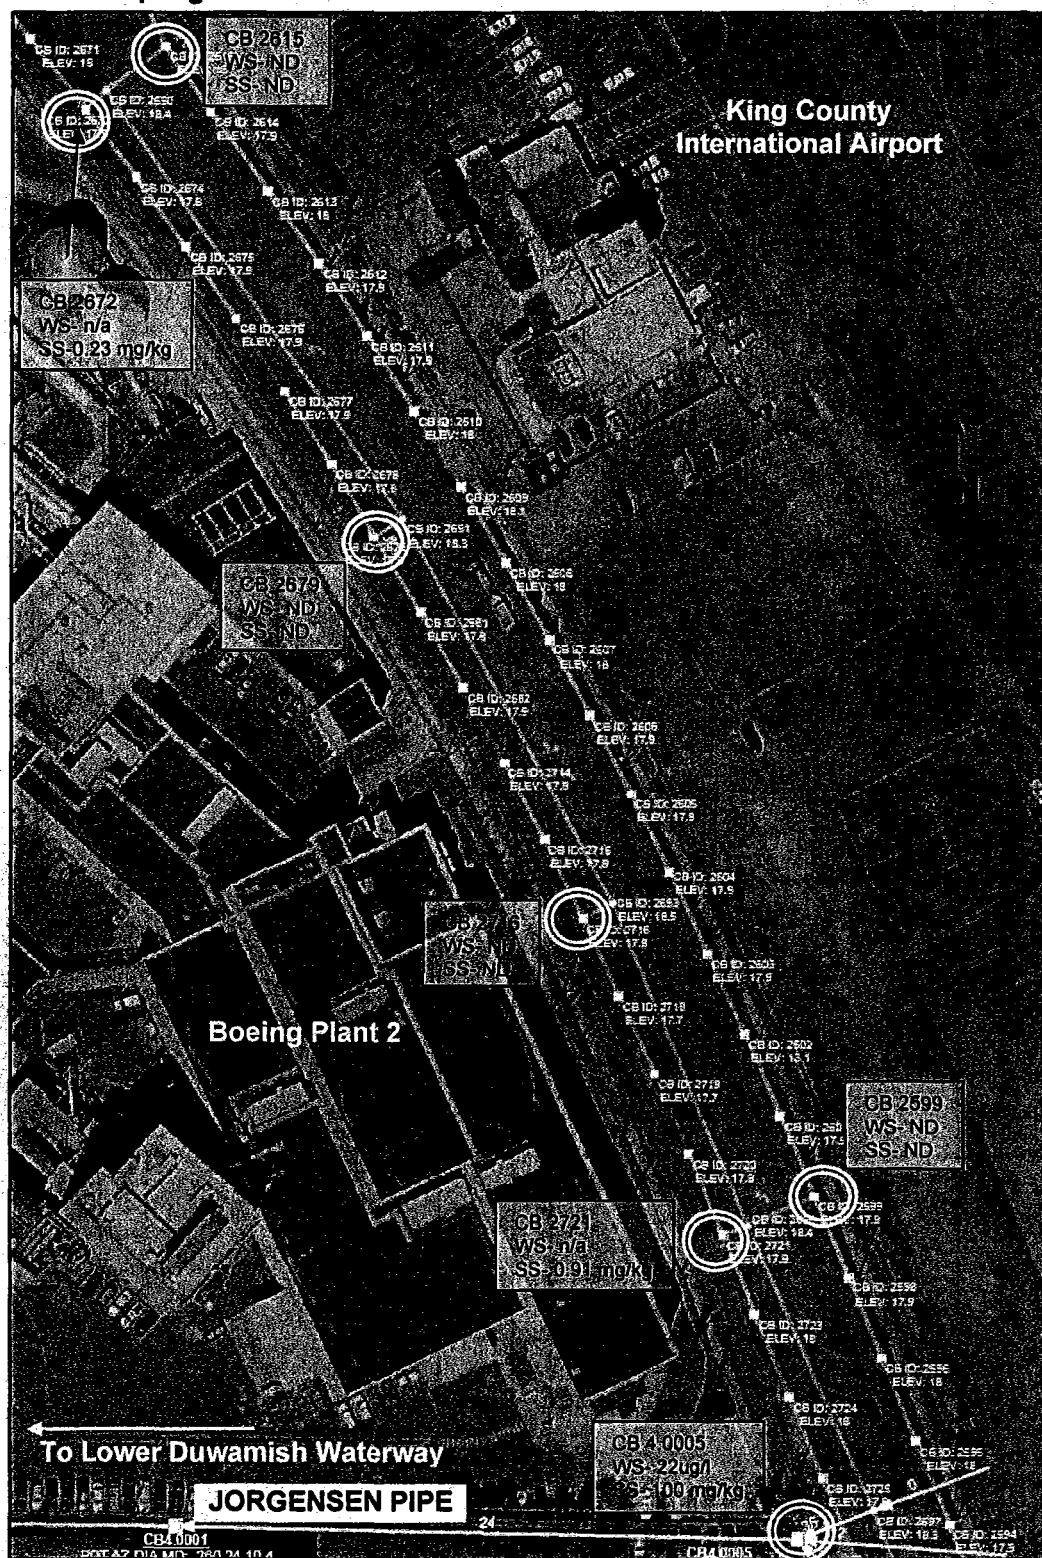
Figure 4. Sampling locations and results

WS: water sample, SS: sediment sample (dry weight), ND: non-detect, n/a: no sample collected
Image provided by City of Tukwila Public Works

Seven sediment samples and five water samples were collected using the methods identified in Section 4.1 from six catchbasins along East Marginal Way and the Jorgensen Pipe manhole. The results from the PCB analysis at NVL are presented below in Table 2 and in Figure 4. Catchbasin reference numbers and locations can also be found on Figure 4.

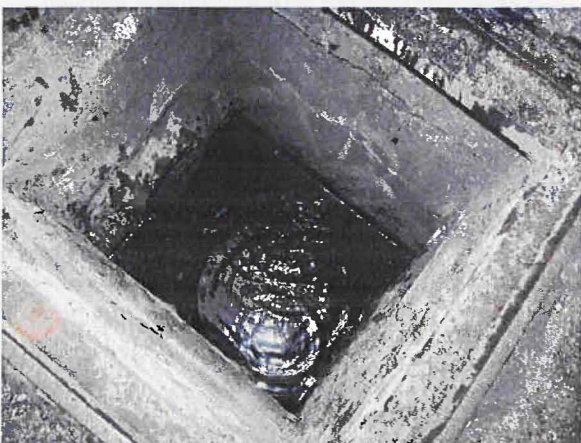
Photo 3. Inside of typical City of Tukwila catch basin in study area

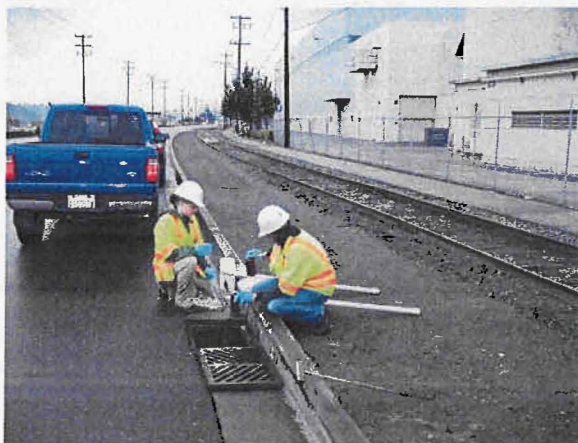
Photo 4. PBS team sampling for sediments and storm water in City catch basin

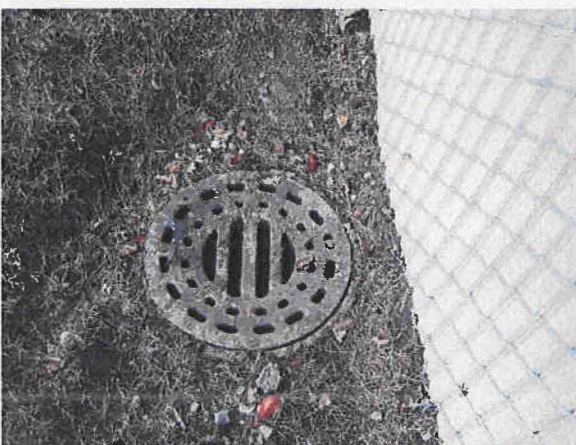
Photo 5. Manhole at top of Jorgensen Pipe along west side of East marginal Way

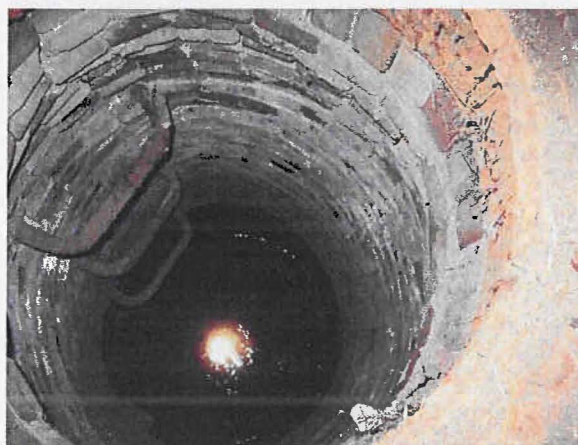
Photo 6. Inside of manhole at top of Jorgensen Forge pipe

levels in the pipe rise and fall with the tides on a regular basis. The pipe is concrete except for the last 110 feet, which is corrugated metal. A large hole was found in the corrugated pipe approximately 60 feet from the outfall. A survey of the concrete pipe shows cracks and deterioration in some areas, particularly at the joints.
